Wood and fiberglass crossarm performance against lightning strikes on transmission towers

Abstract—In the early introduction of transmission lines in Malaysia, wooden crossarms were used on transmission towers where it was first introduced on 66kV lines in 1929 and later on 132kV lines in 1963. However, due to lack of supply of good quality wood, fiberglass crossarms were proposed to replace wooden crossarms on transmission towers in the Peninsular Malaysia. In this paper, an alternative solution to replace wood is discussed. This brings to the selection of Fiberglass Reinforced Polymer (FRP) as an alternative material. Simulation works using SIGMA SLP is presented to demonstrate the voltage stresses of each phase (top, middle and bottom of the crossarm). The simulation explains the defects found on the crossarms due to lightning strikes in a case study. In the case study, the top phase was found to be most affected from lightning activity, followed by the middle and bottom phases. Meanwhile, the Maxwell 3D software was used to model the wood and FRP crossarms on the effect of backflashovers (BFR) and shielding failures (i.e direct hits) resulting in the electric field, voltage di

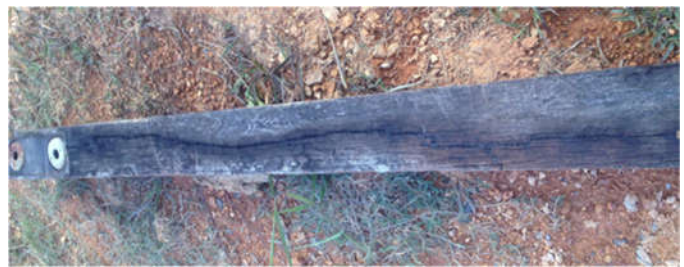
The use of wood as crossarm was believed to be superior due to the arc quenching property which enables it to quench the arc initiated from lightning strikes [2]. However, several cases were reported on failed crossarm due to lightning strikes (see Fig. 1) after a direct hit from lightning.

Fig. 1. Failed wooden crossarm due to lightning strike (Picture courtesy of TNB Asset Maintenance from 132 kV Kuala Krai to Gua Musang line outage due to lightning)

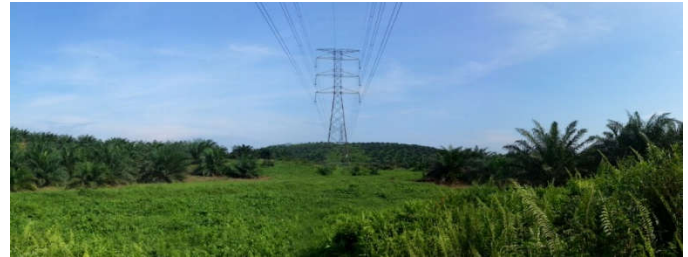
After few years of installing FRP crossarms on transmission towers, several defects were found and reported. One of those are on a 275kV tower where surface tracking was found on the top and middle crossarm, closer to the tower body [11]. Affected tower was located in palm oil plantation area (see Fig. 4) where air pollutant from fertilizers could promote to surface contamination on the exposed crossarms.

Fig. 4. Surrounding area of T105

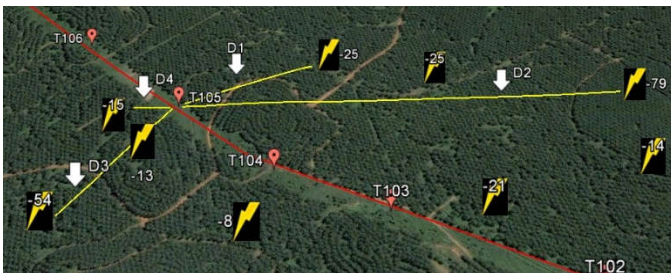
Fig. 7. Strokes nearby T105

In Fig. 7, ten strokes were found within 1 km radius from T105, where the peak current values are: 8kA, 10kA, 13kA, 14kA, 15kA, 21kA, 25kA, 25kA, 54kA and 79kA. All strokes are of negative polarities.

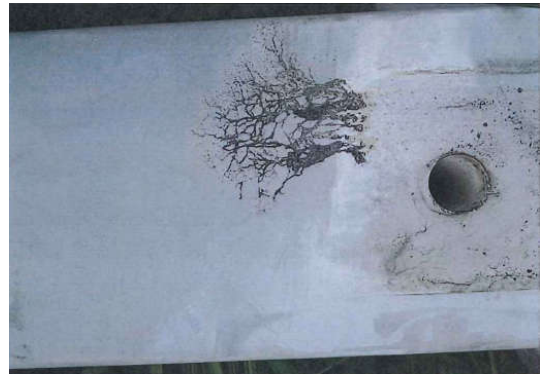
Fig. 8 and Fig. 9 shows the surface tracking on fiberglass crossarm from the top and middle crossarm of T105 respectively. It is observed that the top crossarm experienced more damage compared to middle crossarm. The tracking occurred on the body side of the tower where it started from the tip of the metal fittings. From naked eye observation, the resin was found burnt by the electrical tracking and formed a charred path, creating some cavities which revealed the glass structure [11]. No tracking was found at the bottom crossarm.

Fig. 8. Surface tracking at top crossarm

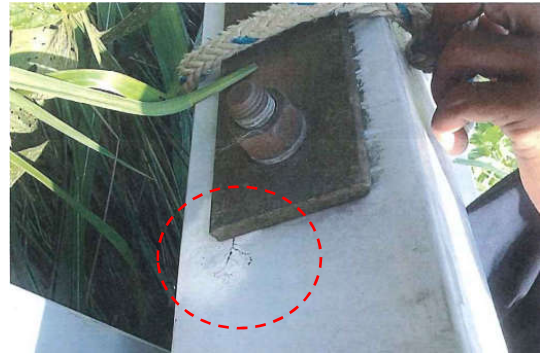
Fig. 9. Surface tracking at middle crossarm

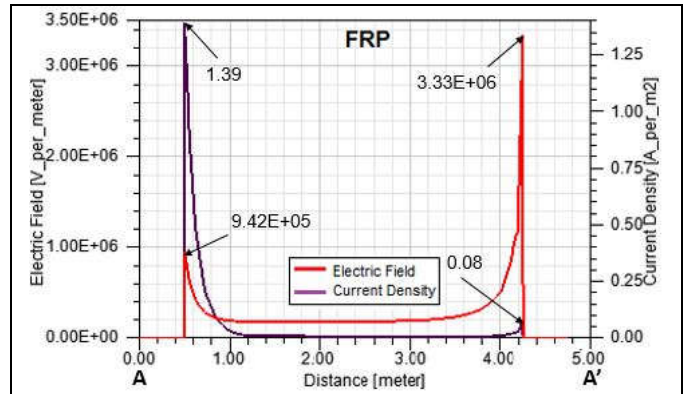
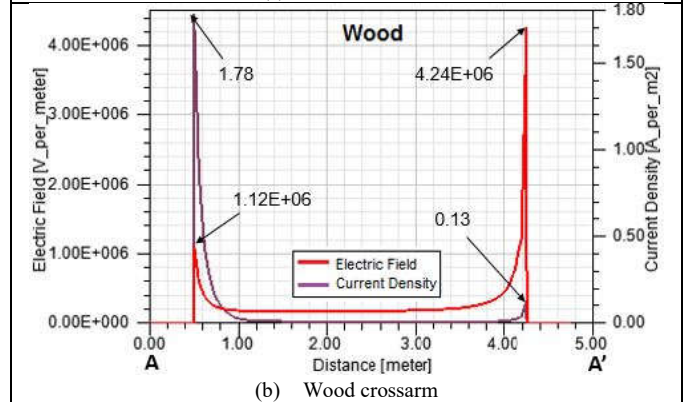
From the measured voltage along wood and FRP crossarm, there were no significant difference in the waveshape which is shown in Fig. 15. High electric field distribution is observed at the tip of the crossarm due to the pointy shape of the crossarm, which is shown in Fig. 16 (a) and (b). This means that concentrated fields were forced into a very small area. Additionally, the vector plot of electric field for the FRP crossarm can be observed in Fig. 17. Current density distribution along crossarms (Fig. 18 & Fig. 19) were also observed where intense current density occurred near the metal fittings at the tower body which is consistent with the fault found at T105. Finally, Fig. 20 shows a gradually decreasing voltage distribution along the FRP crossarm from tower body to the tip of crossarm under impulse current of 1050kV. Similar pattern is observed on wood crossarm (Fig. 21).

Fig. 16. Electric Field and Current Density for FRP and Wood crossarm under BIL 1050kV
