# Multi-Chamber Arrester Field Test Experience on Medium Voltage Overhead Line in Asia

**Abstract**—this paper discuss issues on medium voltage overhead lines related to lightning and consequences of lightning overvoltage. Few standard lightning protection solutions are discussed in terms of expected performances and limitations. Finally, implementation of Multi Chamber Arresters and results after 1 year of operation in high lightning density area, above 9.5 flashes per km<sup>2</sup> per year, are presented.

Paper submitted to the International Conference on Power Systems Transients (IPST2015) in Cavtat, Croatia June 15-18, 2015

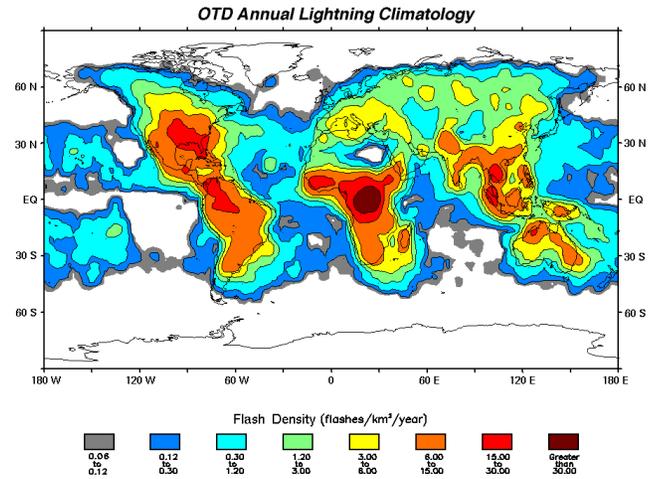
Fig. 1. The global distribution of total lightning flash density observed by the Optical Transient Detector (OTD) (September 1995-August 1996)

From Fuzhou province in China (lat : 26.091325°) down to Bali in Indonesia (lat -8.497054°), a large part of Asian population and therefore medium voltage lines are located in latitudes where flash density shall range from 6 to 20 flashes cloud to ground per year.

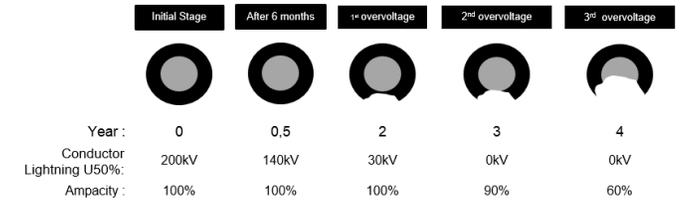
Fig 2. Example of process of degradation of XLPE insulation and breakage of conductors through several years and lightning overvoltages.

When follow current establishes, it rarely breaks the conductor in “one-shot”. In fact, as can be seen in [7], for an insulated copper conductor with core diameter of 13mm it takes 16 cycles (around 250ms) at 5000A short circuit current to break down. Circuit breaker and recloser would clear the fault in much shorter time. Therefore, loss of insulation is a slow evolution most the time hidden by reclosing operations. Figure 2 gives an example of evolution of lightning impulse withstand and ampacity through a few years. Figure 3 gives some pictures of intermediate stages seen in Indonesia and Vietnam.

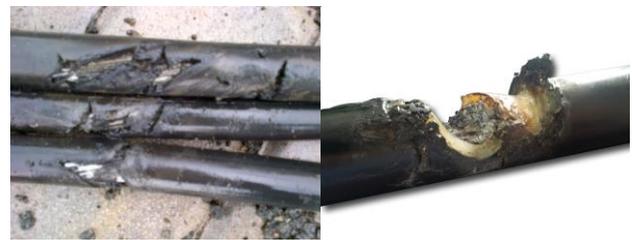
Fig 3. Lightning damage on XLPE insulated conductors. Left: superficial damage of conductor observed in Indonesia. Right: deep damage of conductor observed in Vietnam.

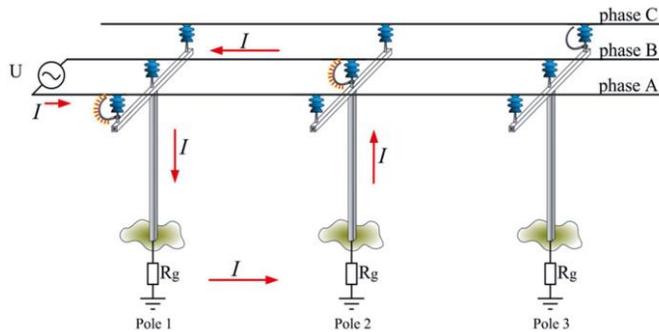
In China and Indonesia, arrester installed were “induced overvoltage” arresters. Their installation is meant to be one per pole, on alternate phases, as show in fig 4. Through this configuration arrester are primarily meant to work in pair or triplets with follow current establishing as double earth-fault or short circuit current through the earth. Thanks to this configuration, faults level are greatly reduced, allowing smaller devices to be used.

Fig 4. Double earth fault current loop, with arresters working in pairs

From 19 arresters that operated during the year of the field test, around 60%, 12 of them, worked in pair in configuration described in Fig 4. At least 1 operation occurred involving 3 arresters, while in at least 3 operations involved only 1 arrester.

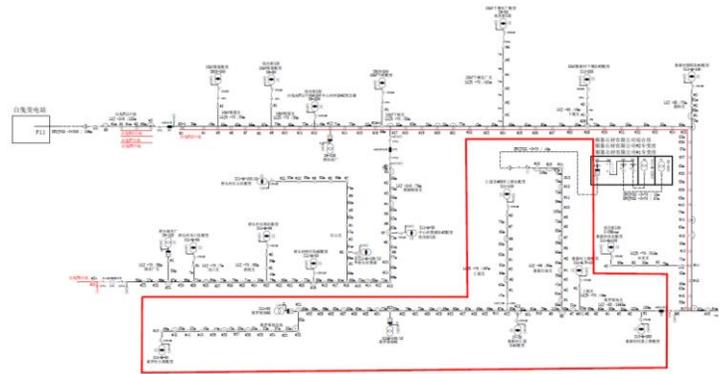
The section chosen is ≈4km long (surrounded in red in Fig 6), which allow, over a year to draw a conclusion on the

Fig 6: White Rabbit 11, “Hang Luo Guo Chang Branch line”. Surrounded by a red line, section chosen for the installation of the SAi10z Multi Chamber Arrester.

White Rabbit F11 total length is 30.9km (fig 6) and composed of 17 branches. Line has an average of 30 outages per year.

“Hang Luo Guo Chang Branch line” is equipped with:

- 67 poles among which
  - 7 section poles
  - 16 tension poles
  - 44 intermediate poles
- 7 transformers 10/0.4kV
- Total length around 4km
- 3 Wires system
- Average pole footing resistance above 30Ω

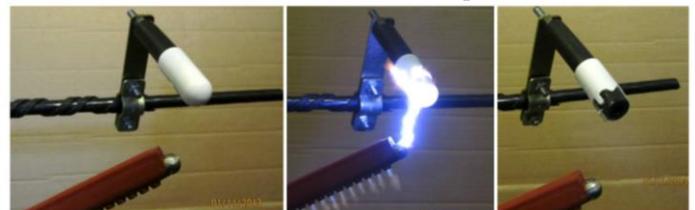
SAi10z operations under lightning impulse will be monitored thanks to one-time-operation indicators.

Fig 7: one-time-indicator. Left: initial state. Middle: during lightning impulse. Right: broken bulb, after lightning.

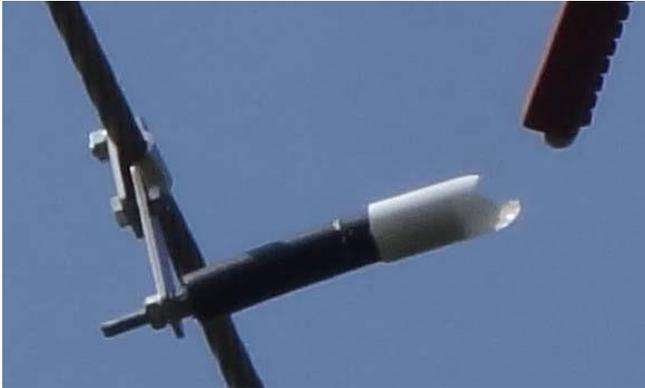
Fig 8: Broken indicator of Arrester on pole #6 of sub-branch

Date of visit	Notes
24 <sup>th</sup> September 2013	Arrester on pole #6 of sub-branch (see Fig 14 operated). After verification on lightning monitoring system, lightning has been indeed present in this area during period
5 <sup>th</sup> December 2013	Routine visit, no particular evolution noted
9 <sup>th</sup> April 2014	Arrester on pole #25 of main branch operated
20 <sup>th</sup> June 2014	Arrester which operated : -main branch on pole #2, -main branch on pole #6-1 and #7 - sub-branch on pole #1 and #2 - main-branch on pole #24

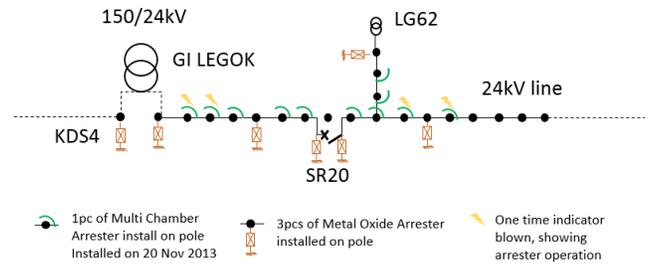
As can be seen in figure 9, several MCA operations have been observed on poles adjacent with standard metal oxide arresters.

Fig 9. Extract of Serpong, Indonesia, field test report reporting operations of MCA on adjacent poles installed with gapless metal oxide arresters.

First conjecture that can be imagined is that, in case of similar footing resistance, residual voltage of MOA was above spark over voltage of SAi020z. In fact residual voltage of gapless metal oxide arresters increases with discharge current. SAi020z spark-over voltage remains below 66.6kV for lightning waveform front time of 5μs and more. For strong lightning discharge, usually with average front time of 5 μs, SAi020z is therefore likely to operate “before” gapless metal oxide arresters.

metal oxide arresters depends their footing resistance. If footing resistance was high, level of overvoltage at adjacent poles might have exceeded MCA sparkover voltage. In this case, both device have operated and contributed to discharge the overvoltage.

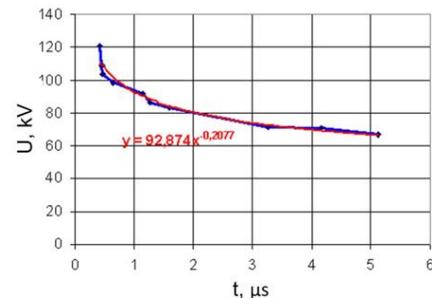
As per IEC standard sparkover voltage is determined through up and down method using 1.2/50us waveform. But sparkover voltage is actually greatly influenced by front time of lightning overvoltage. Tests on MCA, SAi020z, 24kV, installed on the Indonesian field test line, see figure 10, show that sparkover voltage can increase up to 120kV for front time of 0.43μs down to 66.6kV for front time of 5.12μs.

Fig 10. Flashover voltage in function of front time for SAi20z
