Application of Line Surge Arresters on Transmission Lines in Croatian Power System

Abstract - A brief overview of a ten-year experience related to application of the line surge arresters on overhead transmission lines in Croatian power system has been given in this paper. The line surge arresters are mainly used for transmission line lightning performance improvement, for the reduction of overhead lines outages and for increasing reliability of the entire transmission system. The first part of this paper describes the pilot project of line surge arresters installation on the 110 kV overhead line Ston - Komolac from its beginning and reports about conducted measurements and application of gained knowledge on other 110 kV overhead lines in the Croatian transmission system. The second part of the paper points out the main challenges and further perspective of the project.

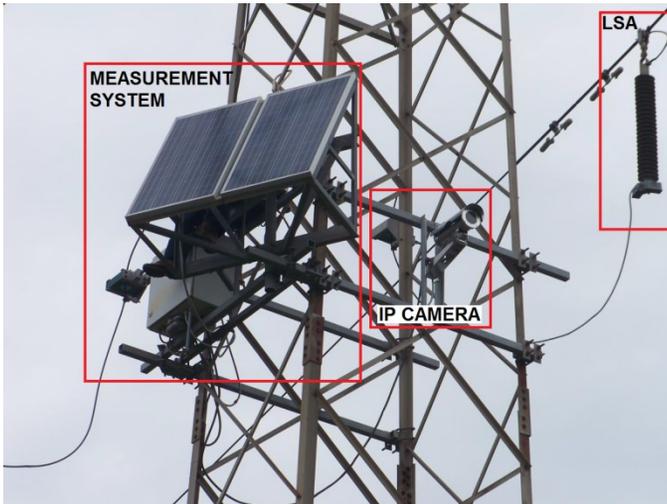
In 2008, several measurements and monitoring devices were installed to the 110 kV overhead line Ston - Komolac. The real-time measurement system (RMS) was installed on transmission line towers no. 38 and 110 in 2009. The RMS, in Fig. 12 consists of the following components:

- a solar power supply (2 solar panels);
- a controller;
- an acquisition unit;
- a communication system.

The RMS contains the sensors for monitoring of the transient current flowing through the ground conductor of the top phase LSA and the specifically developed Rogowski coil that was installed around the tower in order to measure the total lightning current flowing through it (up to 50 kA) [6].

Fig. 12. LSA, real-time measurement system and IP camera on tower no. 38.

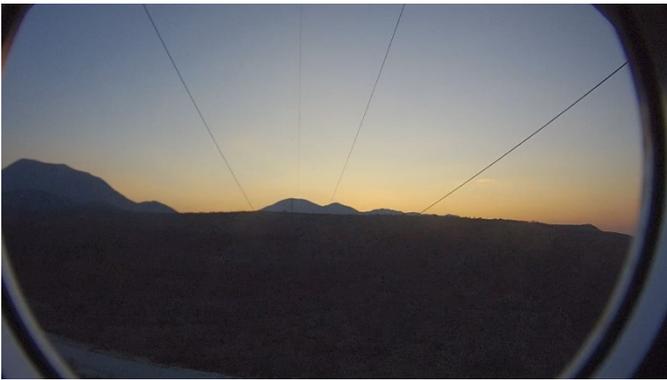
In 2017, two Internet Protocol cameras for visual monitoring of lightning strikes were installed on towers no. 38 and 110 [7] [8]. Both cameras are directed on the side of substation Komolac, in order to gain greater visibility of transmission line and neighbouring towers.

Fig. 13. View from the IP camera installed on tower no. 38.

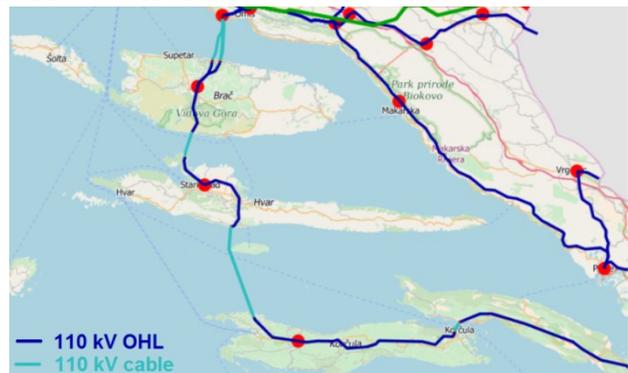
Fig. 14. Part of coastal area of Croatian transmission network that is exposed to significant lightning activities.

Application of LSAs to the overhead lines in Croatian transmission network has continued during the period from 2015 to 2017. LSAs have been installed to the following 110 kV overhead lines located in the coastal area and exposed to significant lightning activities: Ston - Ponikve, Ponikve - Blato and Blato - Stari Grad.
