Wood and fiberglass crossarm performance against lightning strikes on transmission towers

Abstract—In the early introduction of transmission lines in Malaysia, wooden crossarms were used on transmission towers where it was first introduced on 66kV lines in 1929 and later on 132kV lines in 1963. However, due to lack of supply of good quality wood, fiberglass crossarms were proposed to replace wooden crossarms on transmission towers in the Peninsular Malaysia. In this paper, an alternative solution to replace wood is discussed. This brings to the selection of Fiberglass Reinforced Polymer (FRP) as an alternative material. Simulation works using SIGMA SLP is presented to demonstrate the voltage stresses of each phase (top, middle and bottom of the crossarm). The simulation explains the defects found on the crossarms due to lightning strikes in a case study. In the case study, the top phase was found to be most affected from lightning activity, followed by the middle and bottom phases. Meanwhile, the Maxwell 3D software was used to model the wood and FRP crossarms on the effect of backflashovers (BFR) and shielding failures (i.e direct hits) resulting in the electric field, voltage di

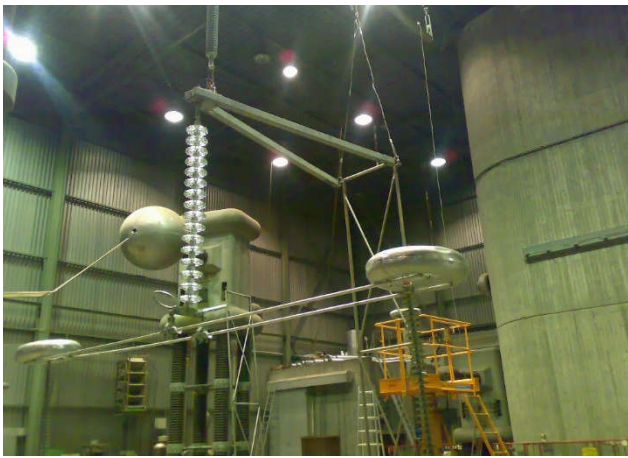
Fig. 2. Test set up for dielectric test on 275kV FRP crossarm

The dielectric test results are presented in Table II;

From Table II, an excellent performance was observed on FRP crossarm comparing to wood especially under wet condition. For both dry and wet condition, FRP crossarms recorded higher withstand value against lightning impulse whereby under dry condition, FRP crossarms recorded 14% higher BIL value compared to wood and 16% higher under wet condition. It was found that the water repellent property in FRP crossarm material which allowed this added advantage.

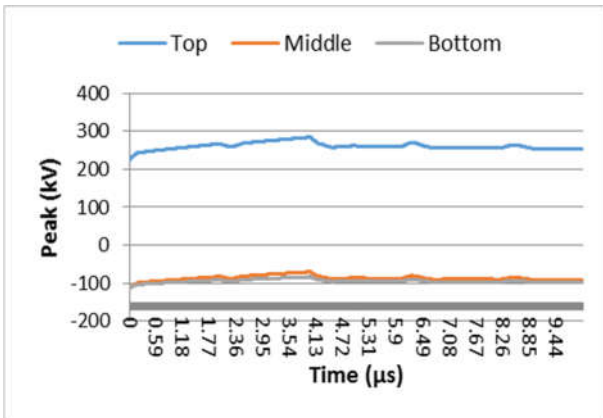
Fig. 10. Peak voltage value when 15kA peak current was applied

Fig. 10 until Fig. 13 shows the simulation results where highest voltage stress was observed at the top crossarm, followed by the middle and bottom crossarms. From the results, peak value of the voltage across insulator when 15kA peak lightning current impulse was applied was less than 300kV. Slightly more than 300kV peak surge was detected when 25kA peak current was applied. For 54kA peak current value, the peak voltage is slightly more than 400 kV and finally 500kV was observed when 79kA peak current was applied. The results explained why this line has never recorded an outage from year 2011 until 2013, which was because the BIL value was never exceeded i.e. 1050kV for 275kV line.

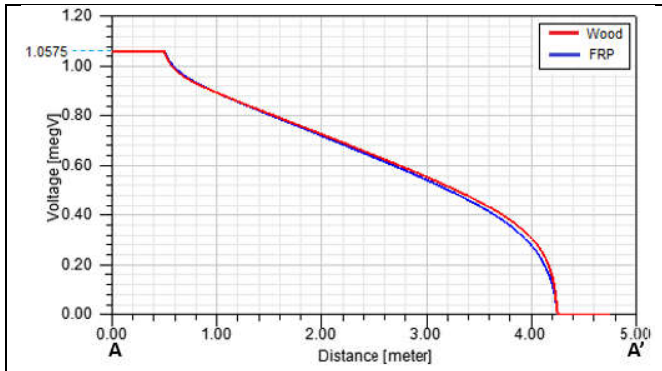
Fig. 15. Voltage measured at wood and FRP crossarm under impulse voltage 1050kV

From the measured voltage along wood and FRP crossarm, there were no significant difference in the waveshape which is shown in Fig. 15. High electric field distribution is observed at the tip of the crossarm due to the pointy shape of the crossarm, which is shown in Fig. 16 (a) and (b). This means that concentrated fields were forced into a very small area. Additionally, the vector plot of electric field for the FRP crossarm can be observed in Fig. 17. Current density distribution along crossarms (Fig. 18 & Fig. 19) were also observed where intense current density occurred near the metal fittings at the tower body which is consistent with the fault found at T105. Finally, Fig. 20 shows a gradually decreasing voltage distribution along the FRP crossarm from tower body to the tip of crossarm under impulse current of 1050kV. Similar pattern is observed on wood crossarm (Fig. 21).

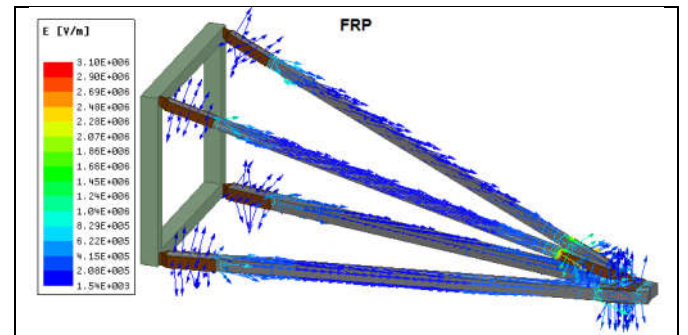
Fig. 17. Electric Field distribution along FRP crossarm

- i. Higher electric field distribution is observed at the tip of the crossarm where concentrated area accumulates fields from 4 crossarm members.
- ii. Large current density distribution was observed near metal fittings, close to the current injection point.
