Electromagnetic transients and failed upward leaders observed during lightning activity in an onshore wind farm

Abstract—At a wind farm in Croatia, lightning activity is monitored across the entire site using a lightning location system, and on a single wind turbine equipped with a Rogowski-coil-based current measurement system and a high-speed camera, all independently GPS-synchronized. In addition to recording lightning flash currents on the monitored turbine, the system is frequently triggered by electromagnetic disturbances caused by nearby lightning flashes. These include direct flashes to two neighboring turbines that share the same cable connection to the substation and have interconnected grounding systems with buried bare conductor, as well as cloud-to-ground flashes to soil near cable routes, where the resulting electromagnetic fields couple onto the cables, causing surges to propagate to the monitored turbine. The camera occasionally captures failed upward connecting leaders from the monitored turbine during these lightning events. This paper presents three cases of flashes to two neighboring wind turbines and two cases of cloud-to-ground flashes to nearby soil, all of

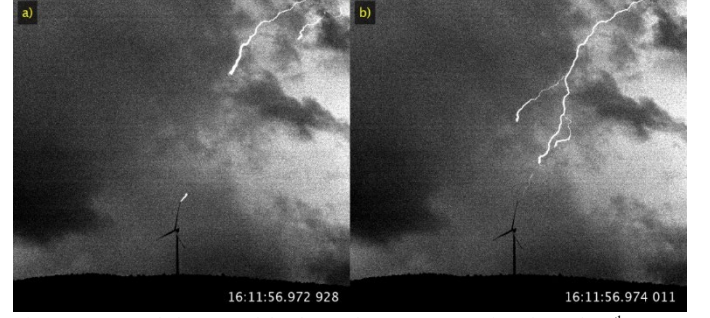
Fig. 2. Stepped downward leader and UCL progression for July 6th, 2023, lightning flash event.

Figure 2 shows two frames from the initial stages of the event, spaced approximately 1 ms apart. These frames clearly illustrate the progression of the downward leader from the cloud and the upward connecting leader initiated from the WT blade, moving towards each other. Figure 3 (left) represents the moment when a sudden increase in luminance occurred on the right side of the HS camera frame as the downward leader approached WTG4. After this moment, the leader began to withdraw and gradually faded away, ultimately failing to connect to WTG4. According to the HS camera's timestamp, the sudden and intense increase in luminance occurred at 16:11:56.975 UTC. This coincided with the moment the LLS registered a stroke hitting the WTG3 to the right of WTG4 (from the camera's perspective) and another stroke hitting WTG6 (left from the camera's perspective). Figure 3 (right) shows the exact locations of the two strokes as determined by the LLS, marked with red crosses. According to LLS, the WTG6 stroke occurred at 16:11:56.975 UTC, while the WTG3 stroke occurred 16:11:56.974 UTC.

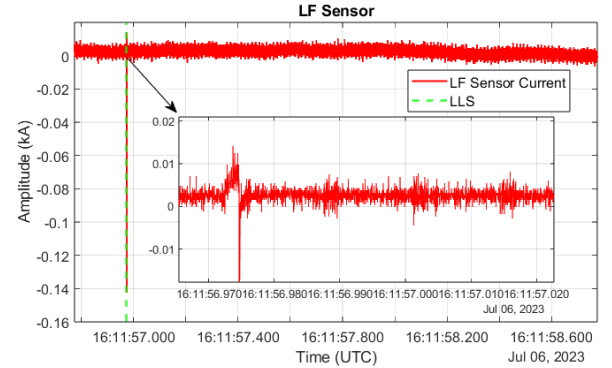
Fig. 4. LF sensor record of July 6th, 2023, lightning flash event: potential continuous current immediately followed by electromagnetic disturbance.

The camera was triggered by the current measurement system. In this instance, the system potentially registered a continuous current associated with an initiated UCL, as shown in Figure 4. Immediately afterward, an electromagnetic transient was observed, caused by a lightning stroke to WTG3. The timing of this stroke, as determined by the LLS, is marked by the vertical line in the figure. Only the timing of the stroke that impacted WTG3 is plotted. No records from the HF sensor are available for this event.

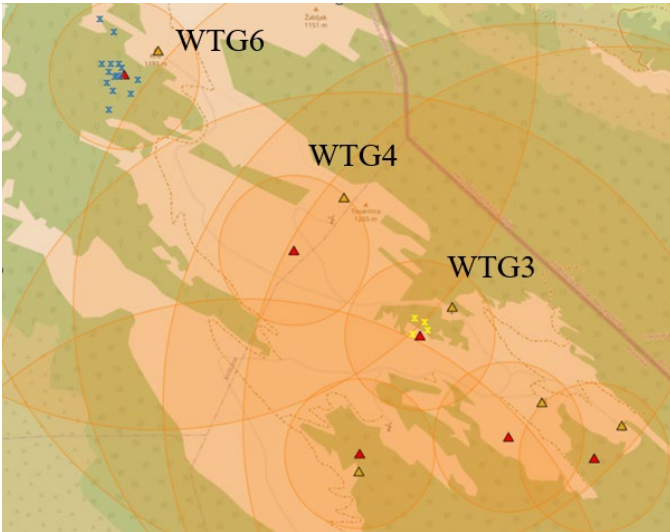
Fig. 5. December 11th, 2022, lightning flash to WTG6: 15 strokes (marked with blue cross); Jan 21st, 2023, lightning flash to WTG3: 4 strokes (marked with yellow cross).

Figure 5 shows the LLS spatial data associated with December 11th, 2022, lightning flash to WTG6, which includes 15 successive strokes located in the collection area of the WT (marked with blue cross), and data associated with the January 21st, 2023, lightning flash to WTG3, which includes 4 successive strokes located in the collection area of the WT (marked with yellow cross).

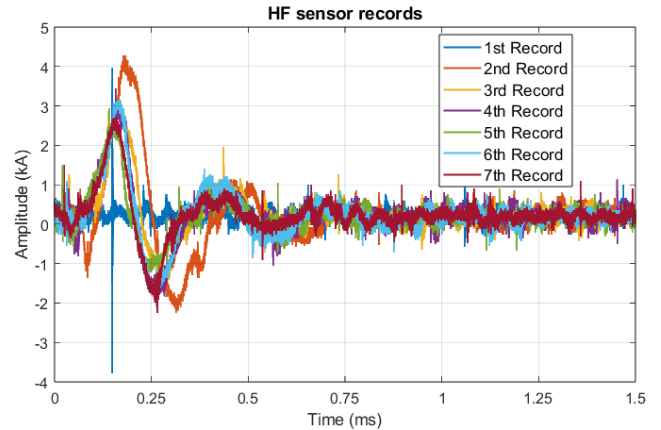
Fig. 7. HF sensor records of electromagnetic transients caused by the December 11th lightning flash to WTG6, aligned to time zero.

The remaining transients generally follow a consistent pattern, both in shape and duration (several hundred microseconds).

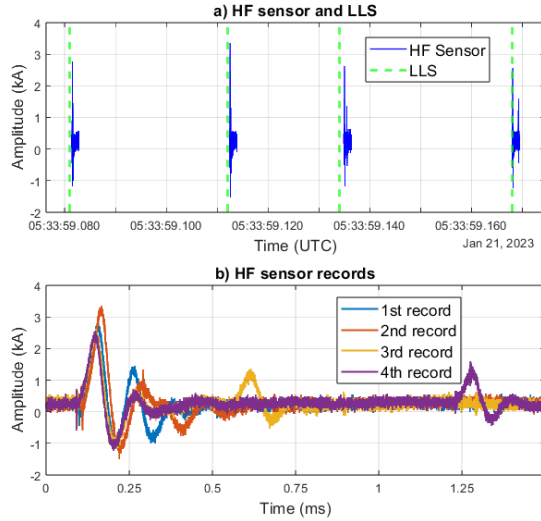
Fig. 8. Electromagnetic transients at WTG4 caused by the January 21st, 2023, lightning flash to WTG3, as recorded by the LF and HF Rogowski coils.

The lightning flash to WTG3 on January 21st, 2023, occurred at approximately 05:33:59 UTC. Figure 8 presents data collected during this event, including a combined plot of HF sensor measurements annotated with vertical lines marking the timings of strokes detected by the LLS (Figure 8a) and a plot of all HF sensor records aligned to time zero to emphasize their similarities in waveform shape and duration (Figure 8b).

For this event, no LF sensor record is available as it was not triggered. The HF sensor, however, captured all electromagnetic disturbances associated with each of the four strokes detected by the LLS. There is approximately a 1 ms offset between the stroke and the corresponding disturbance detected at WTG4, except for the last case, where they are almost perfectly aligned. This discrepancy arises from the LLS

As shown in Figure 8, the disturbances during the initial phase exhibit similar oscillatory behavior, which gradually attenuates overtime. Notably, the third (orange) and fourth (purple) HF sensor records contain additional oscillations occurring later in the event.

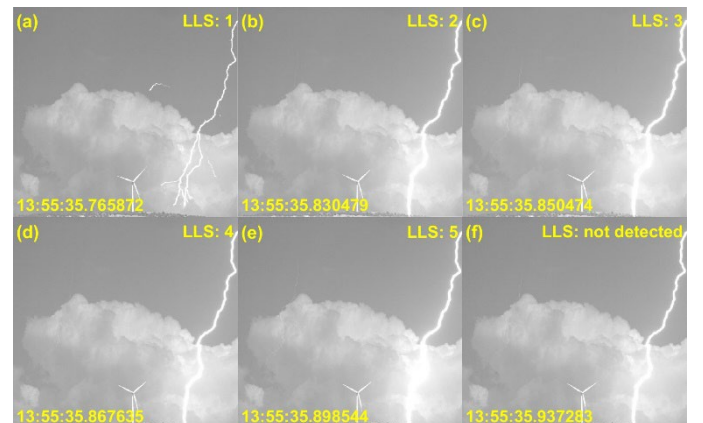
Fig. 10. September 3rd, 2024, lightning flash: HS camera captured failed UCL and six strokes in total.

First, the September 3rd, 2024, lightning event will be analyzed. According to Figure 9a there were five discharges detected with the first one being classified as cloud-to-cloud (yellow cross). Figure 10 shows specific camera frames corresponding to moments around the times when the LLS detected strokes. In the top right corner of Figure 10 there are labels that associate each frame with specific LLS numbering of the stroke used in Figure 10a. Camera captured in total six strokes, one more than LLS as LLS missed the last one. Furthermore, the first stroke, which was categorized as cloud-to-cloud, appears to have hit the ground, as indicated by the first camera frame. From the frames the strokes used the same channel and discharged at the same ground strike point.

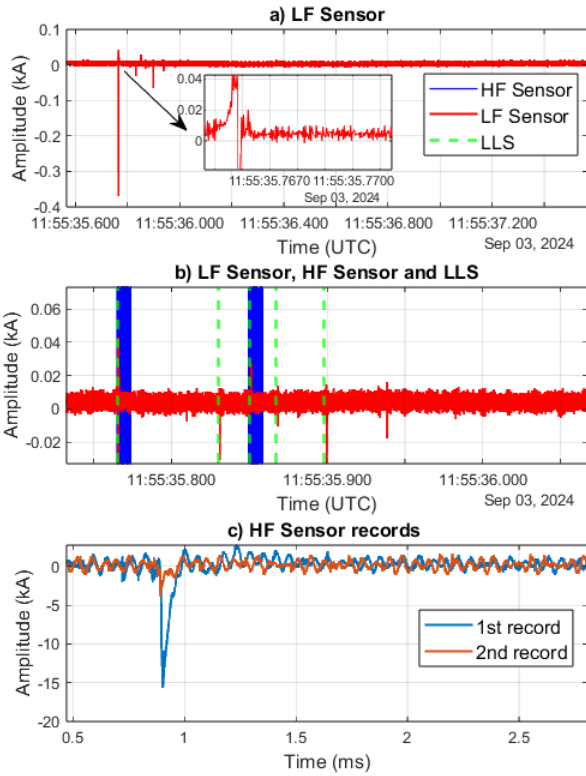
Fig. 11. Continuous current associated with failed UCL and electromagnetic transients at WTG4 caused by nearby CG flash to soil on September 3rd, 2024.

Figure 11 provides information about the electromagnetic disturbances caused by the lightning flash. Specifically, Figure 11a shows the LF sensor measurement of the event, indicating that a UCL occurred on the WT blade. However, the UCL failed, as indicated by the abrupt cessation of continuous current. Figure 12 displays two non-successive camera frames capturing the moment when the UCL was visible. Notably, the UCL and the associated continuous current faded as the flash made its initial connection with the soil. It should be noted that the UCL was visible in more frames than the two shown in Figure 12, but its appearance in the additional frames was much less distinct.

Figure 11b illustrates the LF and HF sensor measurements overlaid with vertical lines representing the LLS-detected stroke timings. As shown in Figure 11b, each vertical line corresponding to an LLS-detected stroke aligns with a local disturbance captured by the LF sensor. The HF sensor detected electromagnetic disturbances associated with two out of the five strokes detected by the LLS: the first and third stroke, following the numbering used in Figure 9a.

These transients are presented in greater detail in Figure 11c, where the corresponding, originally 9-ms long, HF sensor records are displayed relative to each other, enabling better comparison of the waveform shapes of the measured disturbances. The transients exhibit a similar overall waveform shape. Compared to flashes occurring directly on neighboring wind turbines, the transients observed here have a shorter duration (around 0.1 ms) and are not as oscillating.

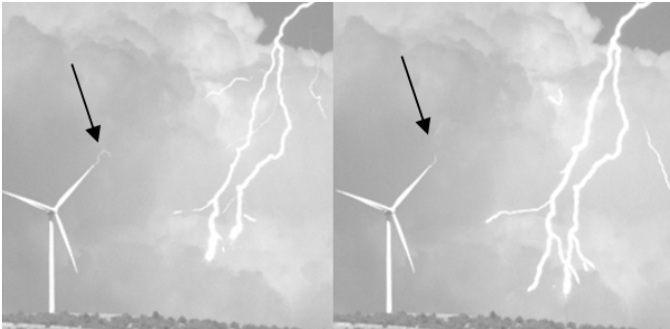
Fig. 12. Non-successive HS camera frames before the first connection, in which the UCL initiated from the blade, are visible.

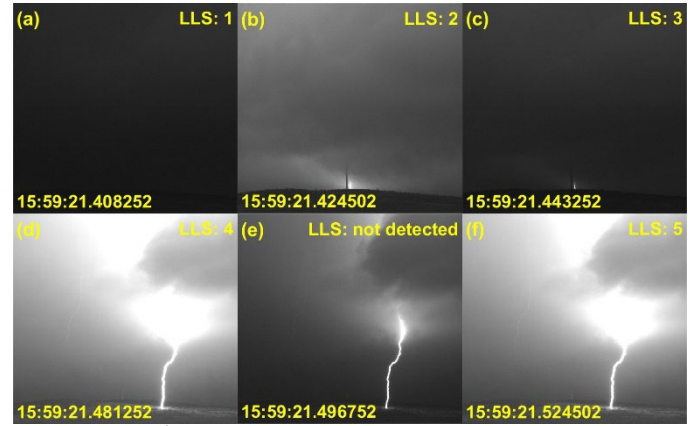
Fig. 13. April 25th, 2023, lightning flash: HS camera captured five strokes in total.

The first camera frame (a) corresponds to the first stroke detected by the LLS. For this stroke, neither the camera nor the measurement system registered any associated disturbance, suggesting that the stroke likely occurred farther away. Additionally, the camera detected one stroke not recorded by the LLS, occurring between strokes 4 and 5, as shown in

As indicated by the LF sensor measurement, it is likely that a UCL was launched during this event. However, it cannot be observed in the camera frames due to cloud cover obstructing a clear view of the WT blades. The timing of the measured continuous current corresponds approximately to the time of the frame (b) in Figure 13. In this frame, the cloud covering the upper part of the WT is clearly visible.

There are two HF sensor records – one is associated with the first flash behind the WT (camera frame (b) in Figure 13) and the other is associated with the first stroke in front of the WT (camera frame (d) in Figure 13).
